3	valve	TR572-F19	1																	
2	disc	L12512-02	1	BG380CL φ12																
1	rim	L1565-01	1	BG330CL φ6																
number	description	drawing	quantity	material	remark															
		part	17.5X6.75(P=145)		DRAWING NO. : L12512-00															
标记	处数	更改文件号	签字	日期	OEM NO. :															
设计		标准化			图样标记	数量	重量	比例												
校对		批准			1			1:6												
审核					共	页	第	页												
工艺		日期			SINO-TEX WHEEL MANUFACTURES INC.

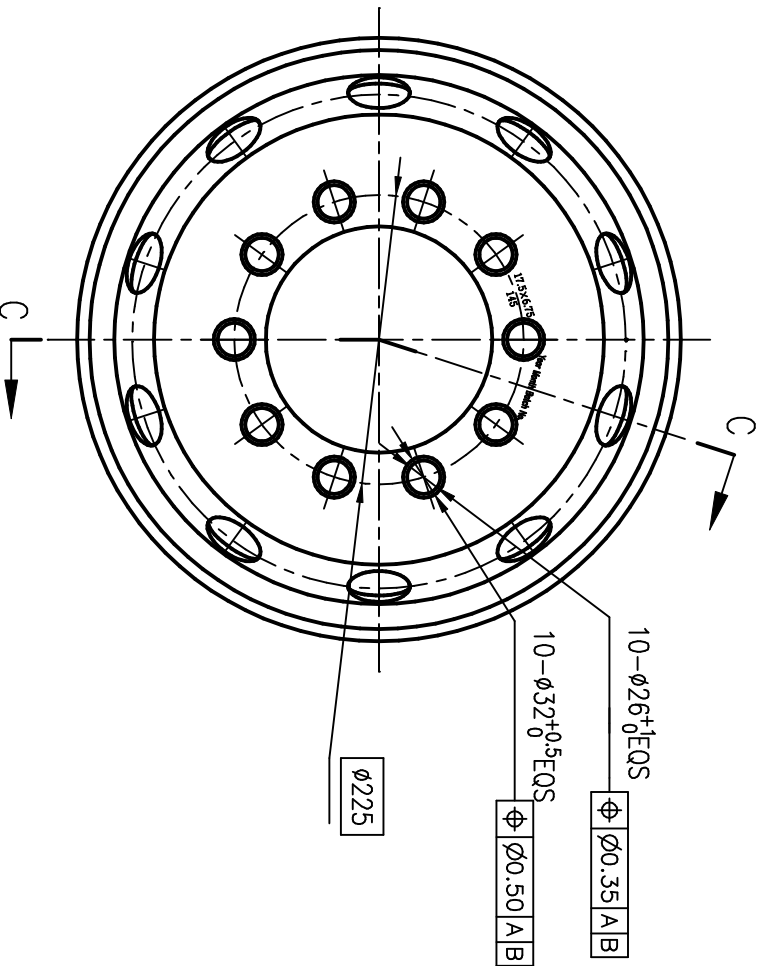
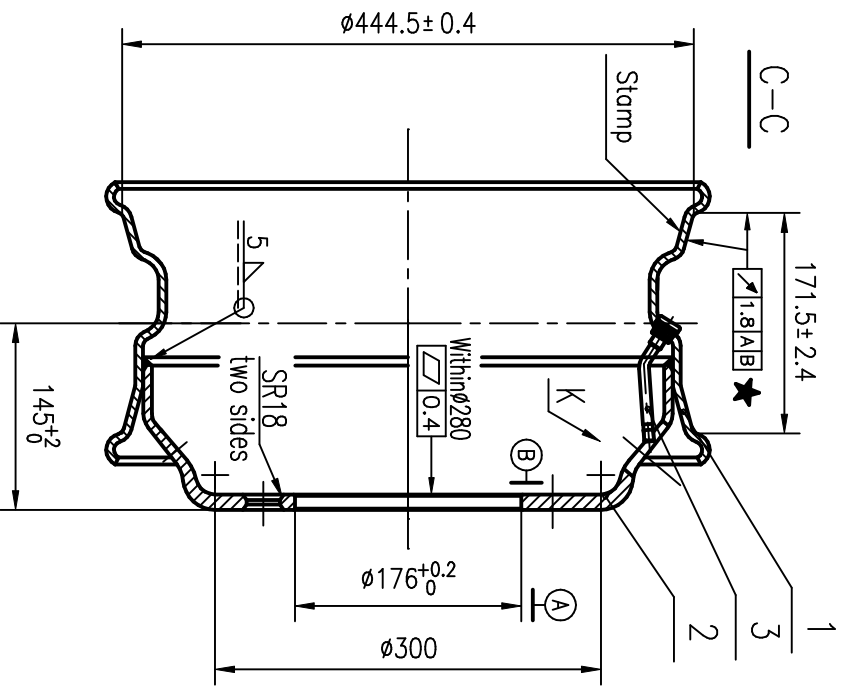
- 1.Rim profile according to TRA.
 - 2.Paint conforms to TQ4 QC/T484--using an electrostatic Epoxy primer coat, painting color according to Customer's requirement.
 - 3.The gradient angle of valve hole and rim welding line is not less than 120° ;
 - 4.Weld firmness,welding line uniformity. Don't allow to have empty weld, off weld,not weld fully and other weld defects.
 - 5.Valve hole and flange area are clean that no burr.
 - 6.Dynamic imbalance quantity is not more than 1500g.cm(63g).
 - 7.Stamp: 17.5x6.75 Year Month Batch No.Shift No.
 - 8.Load:2750Kg
- Test standard:SAE J267
 Test load:cornering:14743N.m minimum cycle times:40,000 ★
 radial:4400Kg minimum cycle times:1,000,000 ★
